CHILD CARE FACILITY ASBESTOS INSPECTION COVER SHEET

Facility Name: Little Cardinals Daycare

Facility Physical Address: 101 Spring Nest Lane Year Built: 1958

ASBESTOS SUMMARY REPORT

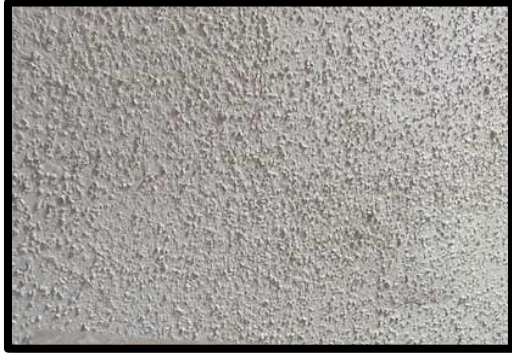
Building	Functional Space (Room/Area/ Exterior)	Material Description	Asbestos %	Recommended Response Action*
Main	Maintenance Room	Ceiling Texture	10%	2-Repair/Maintain
Main	Kitchen Pantry	Orange Floor Tile & Mastic	7%	3-Remove
Main	Pre-K Room	White-Green Floor Tile	3%	2-Repair/Maintain

HGA #2-
White with Gold Speckled Ceiling Texture.
Hazard in Maintenance Room.

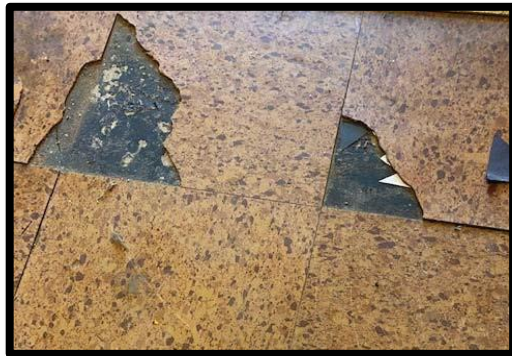
Attached below is the NC – ARPA Asbestos Hazard Assessment and Response Actions table that contains information of the materials identified as asbestos-containing. Only those materials assessed to be a current hazard will require a response action other than maintaining the material in good condition. The facility is required to restrict access to or mitigate the damaged asbestos-containing materials that were determined to be a hazard using the recommended response actions in this report per [10A NCAC 41C .1003\(c\)](#). Access must be restricted to these areas until an appropriate response action can be performed. **Damaged ceiling materials in the Maintenance Room and damaged flooring materials in the Kitchen Pantry and Pre-K Rooms were determined to be a current hazard.**

HGA #3-
9x9 Orange Floor Tile with Black Mastic.
Hazard in Kitchen Pantry.

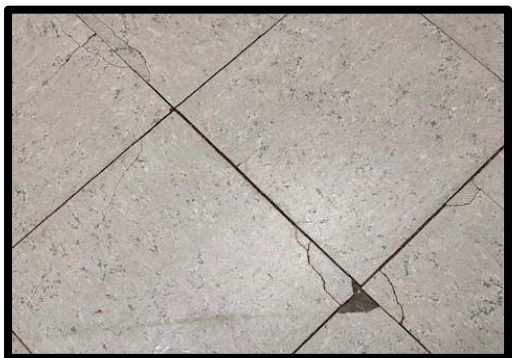
HGA #6-
9x9 White with Green Floor Tile.
Hazard in Pre-K Room.
